Our Ref. No. NGO-6185

22th June, 2011

Re: 30ton Cargo Block of IHI and IHI-WMMP Deck Crane for log operation
木材荷役における IHI 及び IHI-WMMP デッキクレーンの 30ton カーゴブロックについて

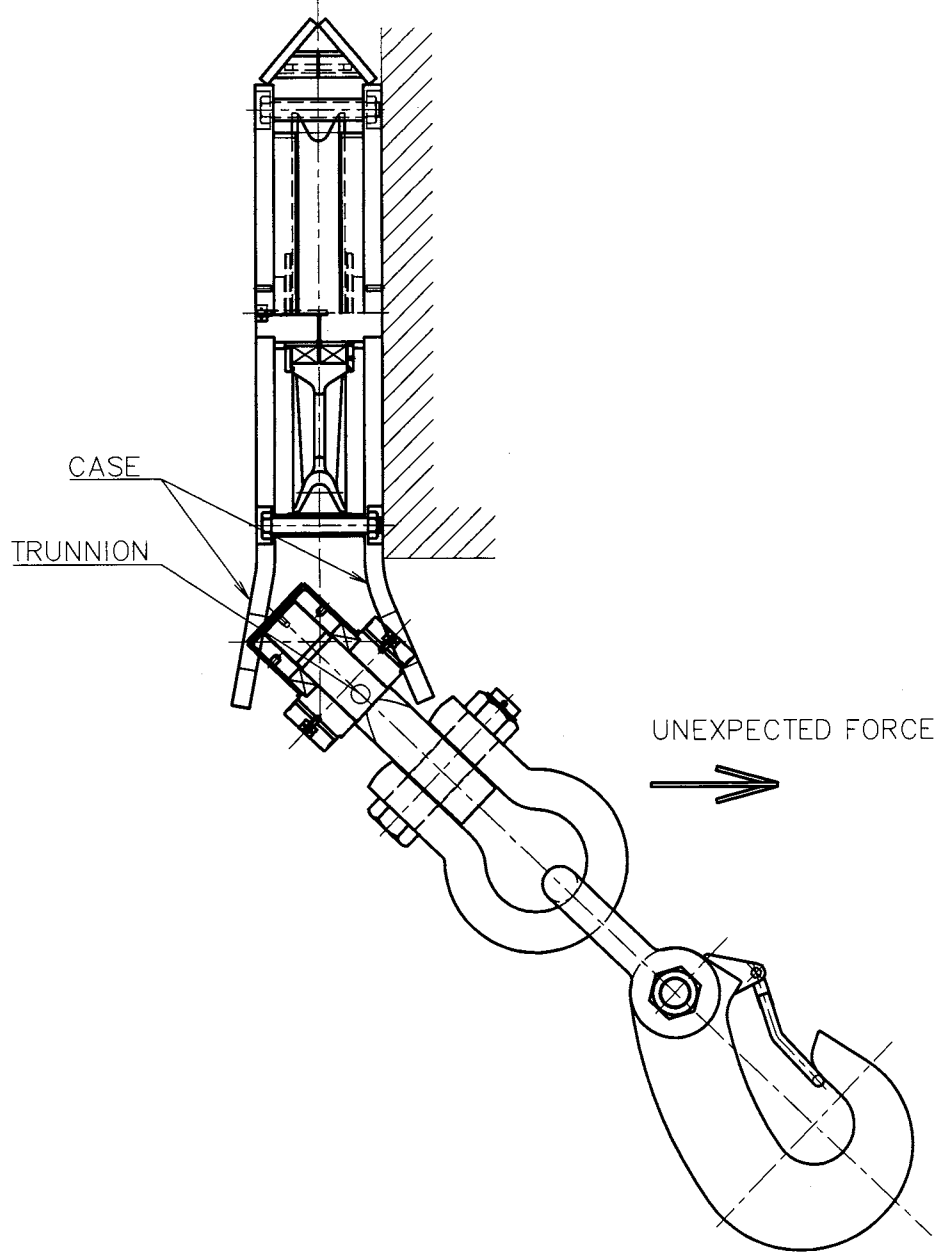
ABNORMAL CONDITION
(FOR EXAMPLE)

We had received the report of cargo block damage that the trunnion dropped out from cargo block's case in loading and unloading of log at New Zealand. (See attached P.3.)

We have been informed that the cause of damage is the out of essentially intended method for using (mishandling) by customer who is related to this matter. We think that this cargo block damage is not based on our quality and design.

Regarding the delivered cargo block, we would like to propose you the best reinforcement plan (two bolts additional improvement plan) as a purpose of preventing the trunnion's drop out. (See attached P.4,5.) Please modify the cargo block before loading and unloading of log.

This reinforcement plan has strength of about 200% compared with standard cargo block. But, please check the daily inspection (deformation, defect, defective motion, etc.) to the cargo block before loading, during loading and after loading.
