**This summary report is issued on 4 December 2014.**

### **The Danish Maritime Accident Investigation Board**

On 13 April 2014, the general cargo ship KARLA C allided with the Masnedø Bridge causing severe damage to the ship and minor damage to the bridge and railway. The DMAIB has investigated the circumstances of the accident, and this report is a summary of the findings.

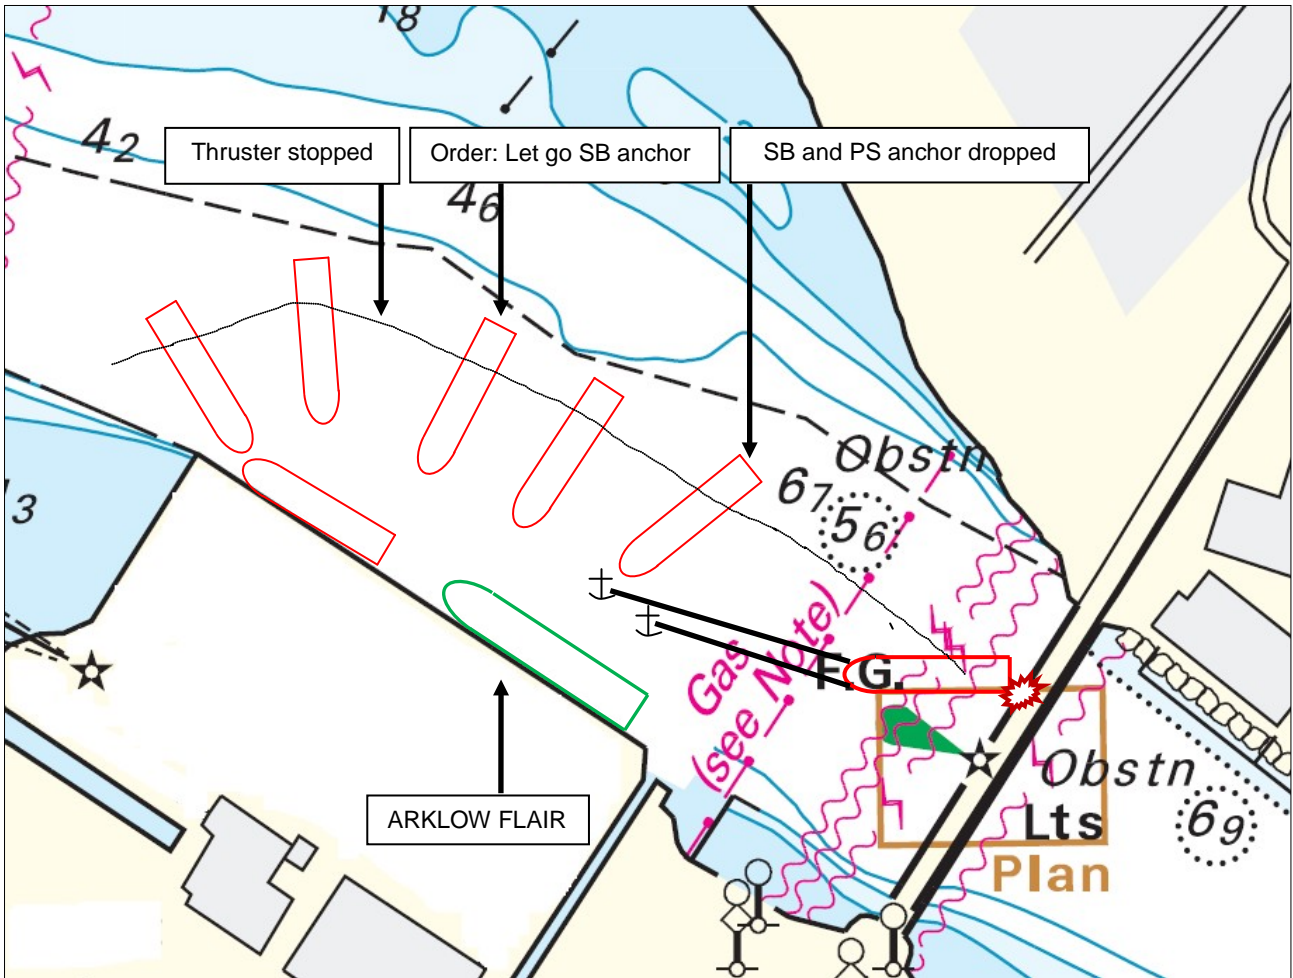
Figure 3: Approximate positions of KARLA C  
Source: DMAIB

As KARLA C approached the berth at a speed of approximately 2-3 knots using the main propulsion and rudder, the pilot realized that the engine manoeuvres, current and wind were affecting the ship more than expected, and that it would be better to turn the ship around and bring it alongside with the bow heading up wind and current. Therefore, the master set the propulsion to astern to stop the ship and turned the rudder to hard starboard while using the bow thruster to assist in turning the ship around by starboard side. Halfway in the turn the thruster overheated after having been operated for a few minutes, malfunctioned and stopped (figure 3).

In order to avoid colliding with the ship (ARKLOW FLAIR), which was moored alongside approximately 20 metres from the bow, the master set the propulsion to full astern to stop the forward momentum of the ship, but the master believed that the manoeuvre moved the ship too fast towards the northern part of the channel and eventually had to be stopped – otherwise the ship would run aground on the bank on the other side of the port. It was not possible to use the main engine and rudder to manoeuvre the ship out of the situation because the ship was too large and was equipped with pitch propellers that would not respond quickly enough. The distance to the bridge was approximately 200-300 metres.

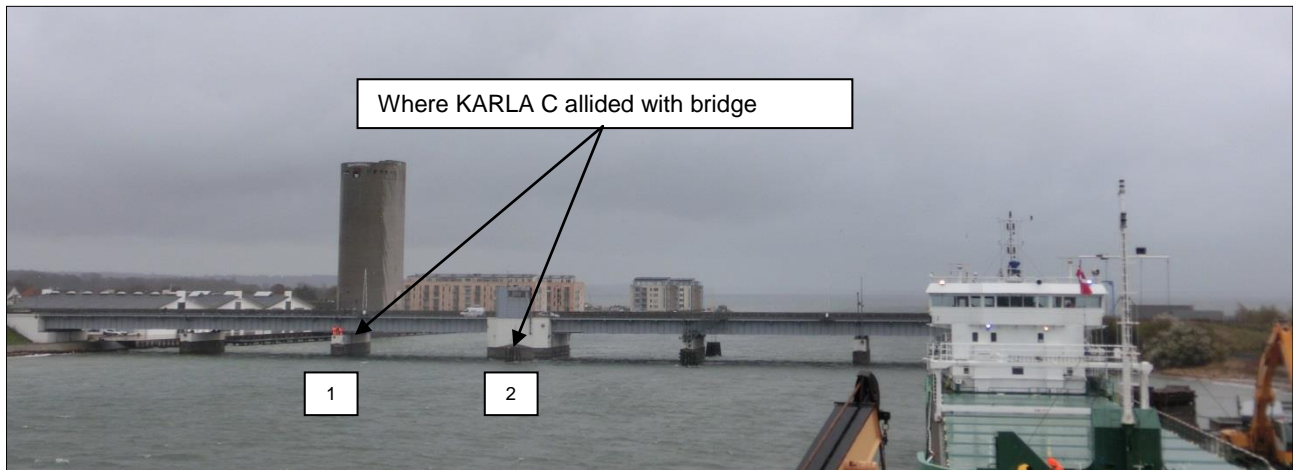
Figure 4: Overview of Masnedsund Bridge  
Source: DMAIB

Once both anchors had been dropped, the ship swung to port (heading to starboard) so the bow turned heading into the current. At 2247, the aft part of the ship allided with bridge pillar no. 2 and shortly after allided with the duc d'alpe west of the centre support structure (figure 4). The anchors were holding the ship upstream heading in a westerly direction and the situation was stabilized.

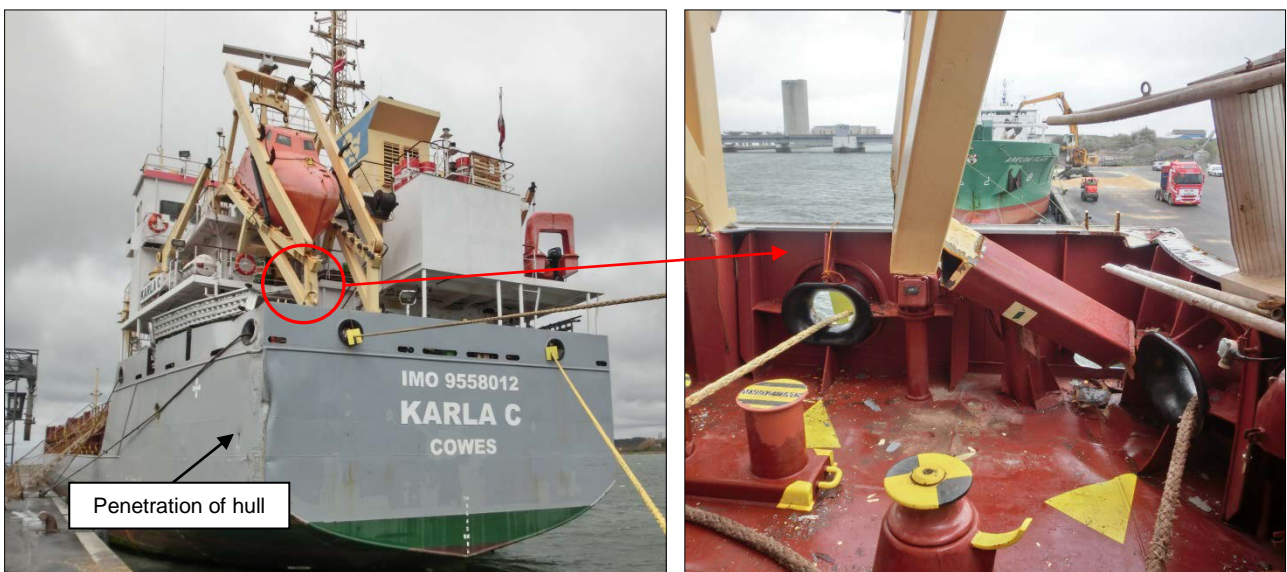
Figure 5: Damage to KARLA C  
Source: DMAIB

KARLA C suffered considerable damage to the hull on the port quarter, the gangway and the life boat davit. Furthermore, the port side fresh water tank was penetrated and was nearly emptied (figure 5).

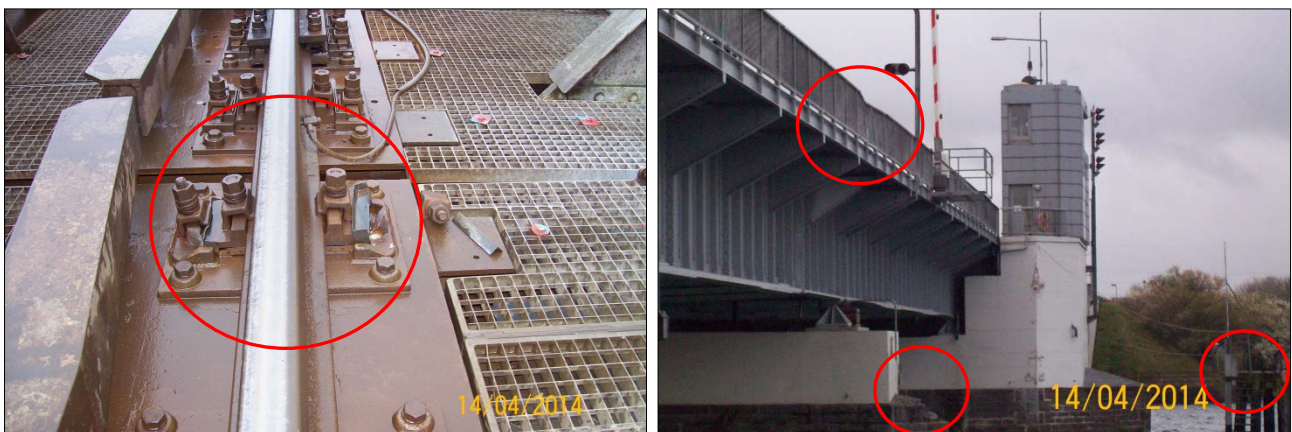
Figure 6: Damage to bridge  
Source: Rail Net Denmark

The bridge was struck on the western side where the footpath and road were situated. The railway was on the eastern side. There was damage to the duc d'alpe west of the centre pillar and the bridge construction including the footpath, light mast, bridge support structure and railway (figure 6). The spans had shifted approximately 10-15 mm.

When the tracks had been repaired temporarily, it was recommended that the trains continue their regular service at reduced speed until the supporting structures had been permanently repaired.
