Danish Maritime Accident
Investigation Board

SUMMARY REPORT

December 2014

KARLA C
Allision on 13 April 2014

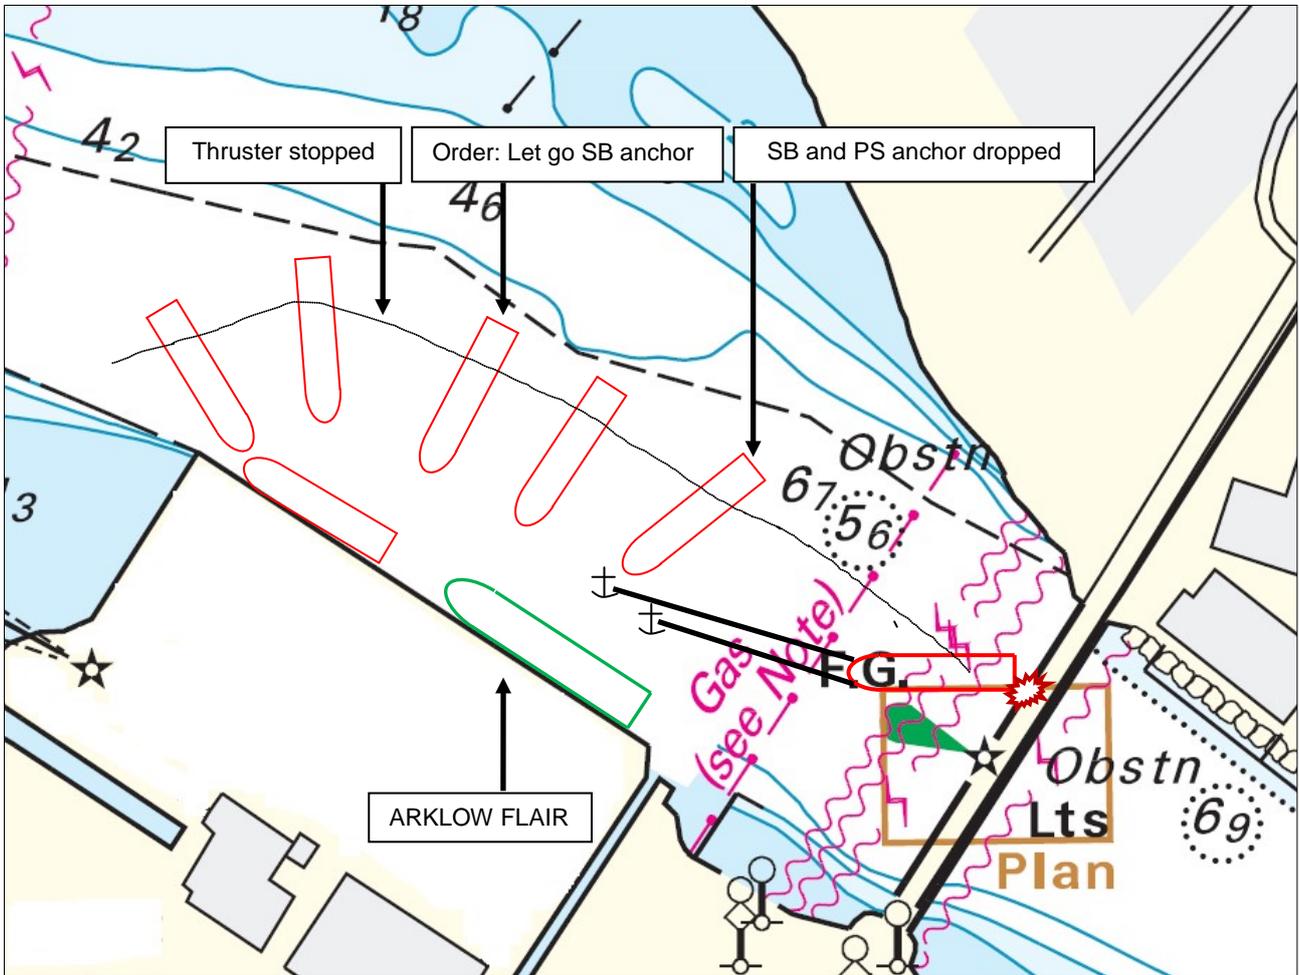
Figure 3: Approximate positions of KARLA C
Source: DMAIB

As KARLA C approached the berth at a speed of approximately 2-3 knots using the main propulsion and rudder, the pilot realized that the engine manoeuvres, current and wind were affecting the ship more than expected, and that it would be better to turn the ship around and bring it alongside with the bow heading up wind and current. Therefore, the master set the propulsion to astern to stop the ship and turned the rudder to hard starboard while using the bow thruster to assist in turning the ship around by starboard side. Halfway in the turn the thruster overheated after having been operated for a few minutes, malfunctioned and stopped (figure 3).

In order to avoid colliding with the ship (ARKLOW FLAIR), which was moored alongside approximately 20 metres from the bow, the master set the propulsion to full astern to stop the forward momentum of the ship, but the master believed that the manoeuvre moved the ship too fast towards the northern part of the channel and eventually had to be stopped – otherwise the ship would run aground on the bank on the other side of the port. It was not possible to use the main engine and rudder to manoeuvre the ship out of the situation because the ship was too large and was equipped with pitch propellers that would not respond quickly enough. The distance to the bridge was approximately 200-300 metres.

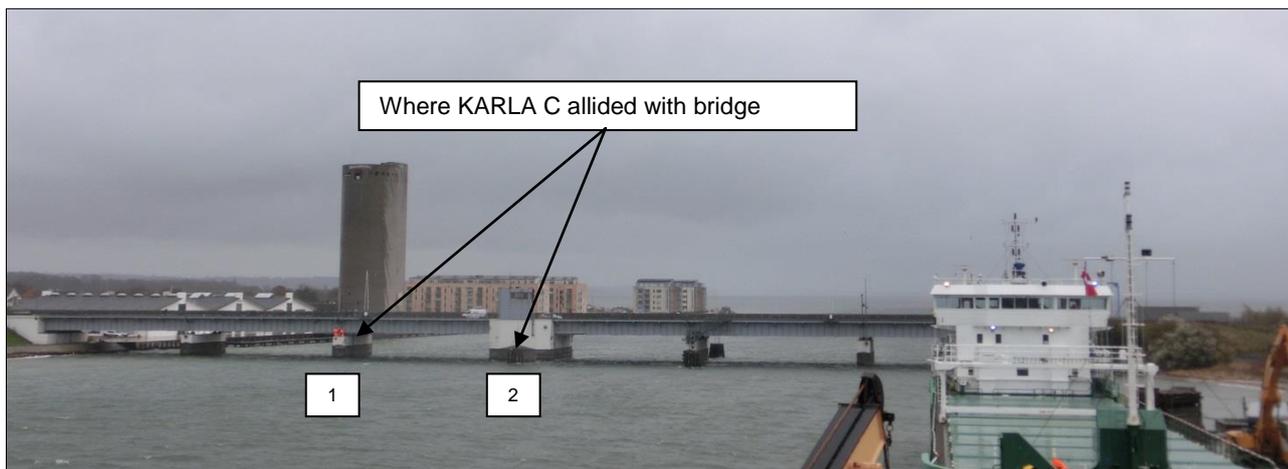
Figure 4: Overview of Masnedsund Bridge
Source: DMAIB

Once both anchors had been dropped, the ship swung to port (heading to starboard) so the bow turned heading into the current. At 2247, the aft part of the ship allided with bridge pillar no. 2 and shortly after allided with the duc d'alpe west of the centre support structure (figure 4). The anchors were holding the ship upstream heading in a westerly direction and the situation was stabilized.

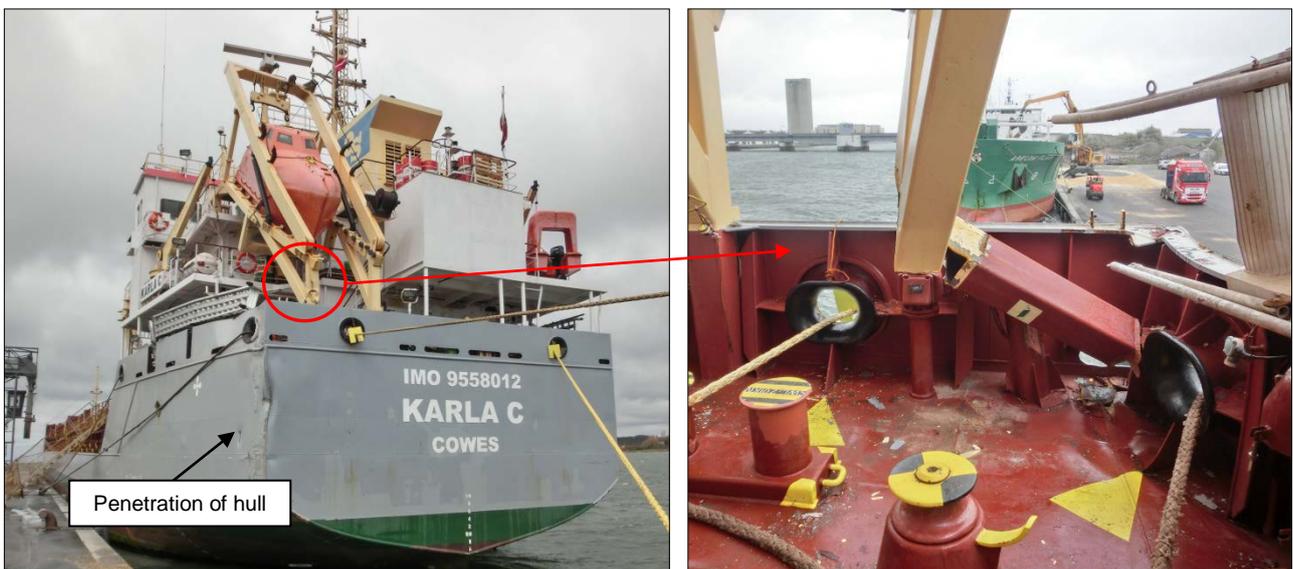
Figure 5: Damage to KARLA C
Source: DMAIB

KARLA C suffered considerable damage to the hull on the port quarter, the gangway and the life boat davit. Furthermore, the port side fresh water tank was penetrated and was nearly emptied (figure 5).

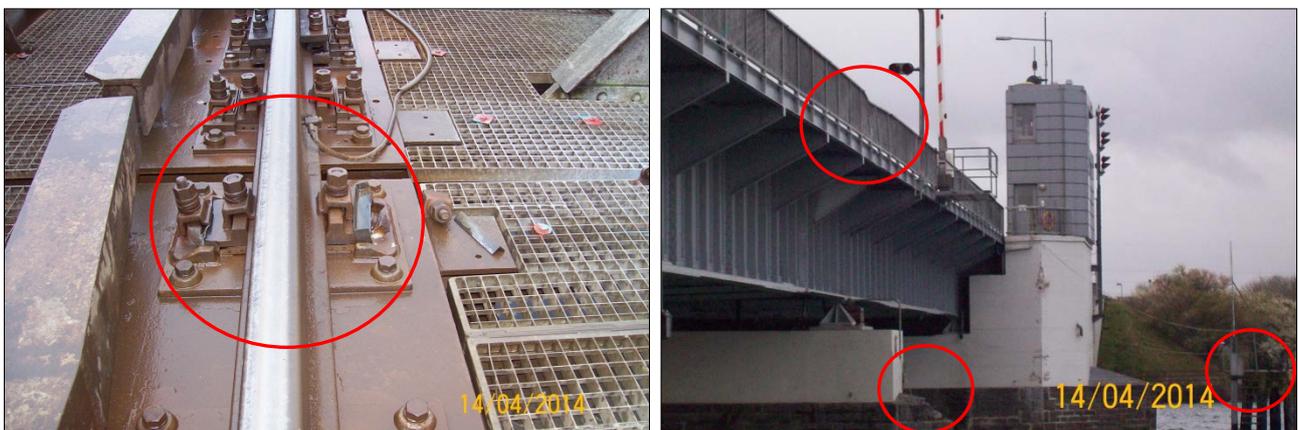
Figure 6: Damage to bridge
Source: Rail Net Denmark

The bridge was struck on the western side where the footpath and road were situated. The railway was on the eastern side. There was damage to the duc d'alpe west of the centre pillar and the bridge construction including the footpath, light mast, bridge support structure and railway (figure 6). The spans had shifted approximately 10-15 mm.

When the tracks had been repaired temporarily, it was recommended that the trains continue their regular service at reduced speed until the supporting structures had been permanently repaired.
