**Report on the Investigation
of the collision between M/V M.KIMITSU and
JINTANG Bridge
on Nov. 16 2009**

Maritime Safety Administration of People's Republic of China

June 12 2010

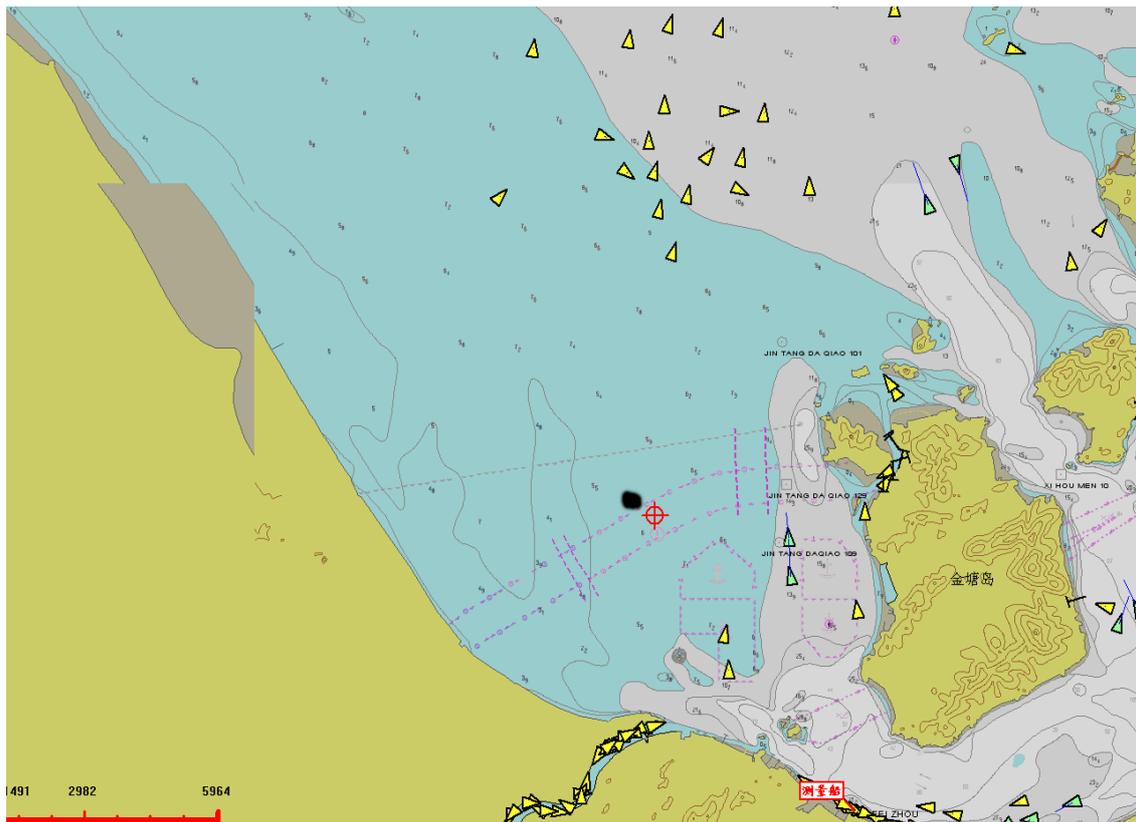
The water area near the anchor position, located in the north side of JINTANG Bridge, was open area with mud bottom and 6 to 9 meters depth on chart. While the depth of M/V M.KIMITSU's anchor position assigned by captain was 6.8 meters on chart, and the nearest distance to the Bridge was about 1 Nautical miles. The anchor position locates in the anchor forbidden area.

The follow sketch based on AIS view map shows the anchor position of M/V M.KIMITSU.
