Our Ref. No. NGO-6185

22th June, 2011

Re: 30ton Cargo Block of IHI and IHI-WMMP Deck Crane for log operation
木材荷役における IHI 及び IHI-WMMP デッキクレーンの 30ton カーゴブロックについて

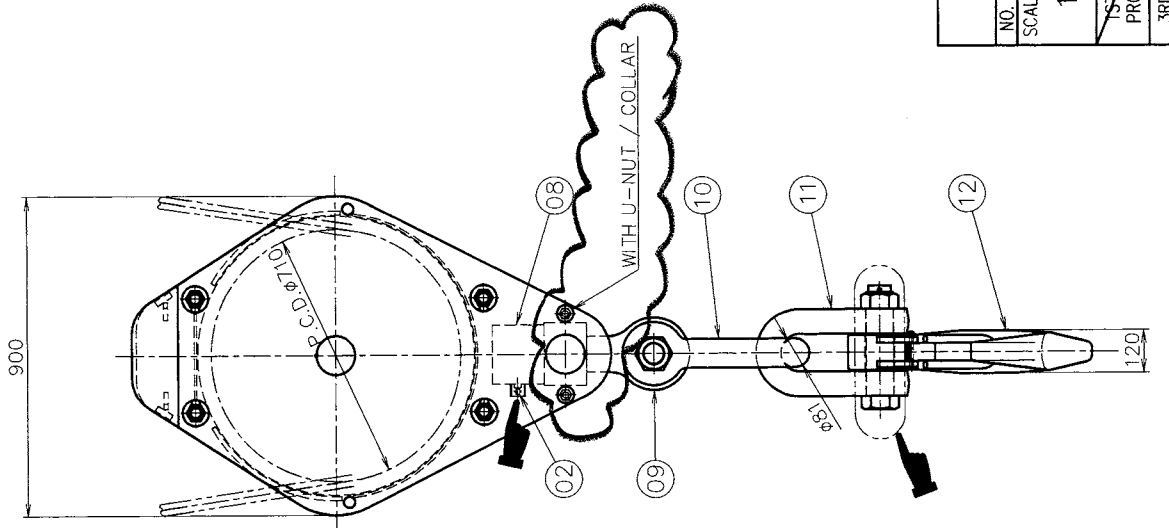
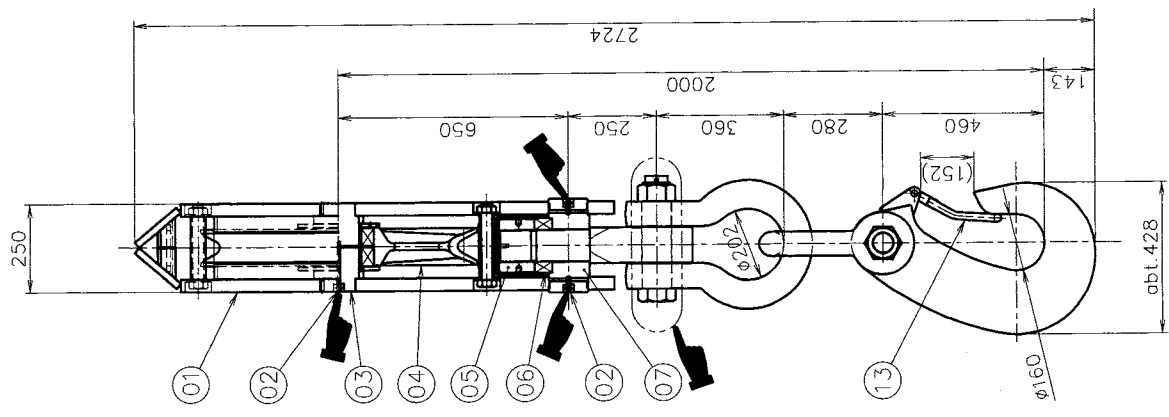
FOR REFERENCE

We had received the report of cargo block damage that the trunnion dropped out from cargo block's case in loading and unloading of log at New Zealand. (See attached P.3.)

We have been informed that the cause of damage is the out of essentially intended method for using (mishandling) by customer who is related to this matter. We think that this cargo block damage is not based on our quality and design.

This reinforcement plan has strength of about 200% compared with standard cargo block. But, please check the daily inspection (deformation, defect, defective motion, etc.) to the cargo block before loading, during loading and after loading.
